# **Reservoir & South Tower**

#### USMNPW-LOC860.001

Topics: potable, stratification/water age, chloramine, short-circuiting, ice buildup, nitrification

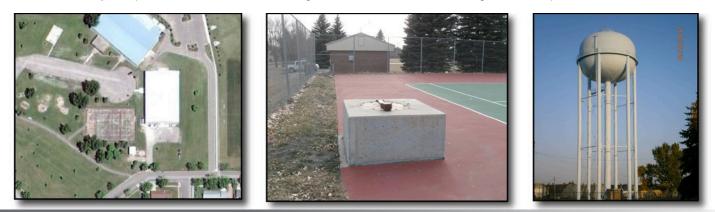
Aerial view of the Reservoir under three tennis courts; the Reservoir access hatch; the elevated South Tower.

**Solution:** August 2011, the City's Water Department installed one GridBee GS-12 submersible mixer in the Reservoir. The GS-12 is located about 50' from the hatch test point, in the short-circuit path between inlet and outlet (see illustration on page 2). Following a successful year of mixing in Point Reservoir and the

summer 2012 repair, cleaning, and repainting of the South Tower, a second GS-12 mixer was installed in the South Tower in August 2012. The GS-12 is suspended below the hatch just above coned lower portion of the tank floor.

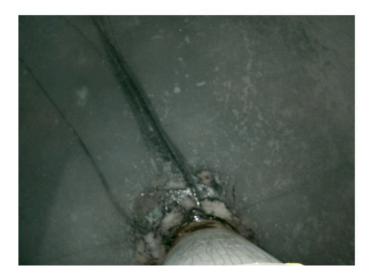
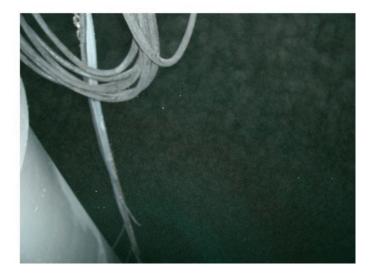
Despite the difficult photographic environment, the left photo shows significant ice buildup in the elevated South Tower in winter 2011-2012. The right photo shows virtually no ice one year later, following the installation of the GS-12 mixer in August 2012, despite the colder winter temperatures.

In the elevated South Tower, a tank inspection was performed in early March 2013. Though winter 2012 – 2013 has been much colder than the previous year, the southeast side of the tank had minimal surface ice formation while the remainder of the tank was ice-free. This tank had substantial ice buildup in winter 2011-2012. The City views this as a clear indication that the addition of the GS-12 mixer has provided sufficient mixing to effectively reduce ice formation during the cold winter months.
